**ELECTRICAL RESISTIVITY IMAGING FOR  
PRELIMINARY ASSESSMENT OF ROAD FAILURES IN OGBIA  
LGA, BAYELSA STATE, NIGERIA**

**Abstract:** Road failure in parts of Bayelsa State Nigeria has been constituting nuisance to human and vehicular activities in the area. This study was designed to investigate the geologic features responsible for road failure in parts of Ogbia Local Government Area of Bayelsa State, Nigeria. Electrical resistivity method involving 2D imaging of the failed parts of Otuoke-Onuebum and Imiringi-Emeyal 2 Roads were conducted on four profiles normal to the strike of the affected parts. The data collected were tomographically inverted and the results predominantly showed that the failed portions of the roads are characterized with very low resistivities ranging from  $0.094 \Omega\text{m}$  to  $173 \Omega\text{m}$ . These results suggest that the formation underlying the failed portions of the roads are predominantly clays and peat, loam and mud. These suggest that clay volumetric variation due to variation in moisture content most likely caused the failure of some parts of the roads. The thicknesses of the clay formations range from 2 m to 8 m. Also, in the parts

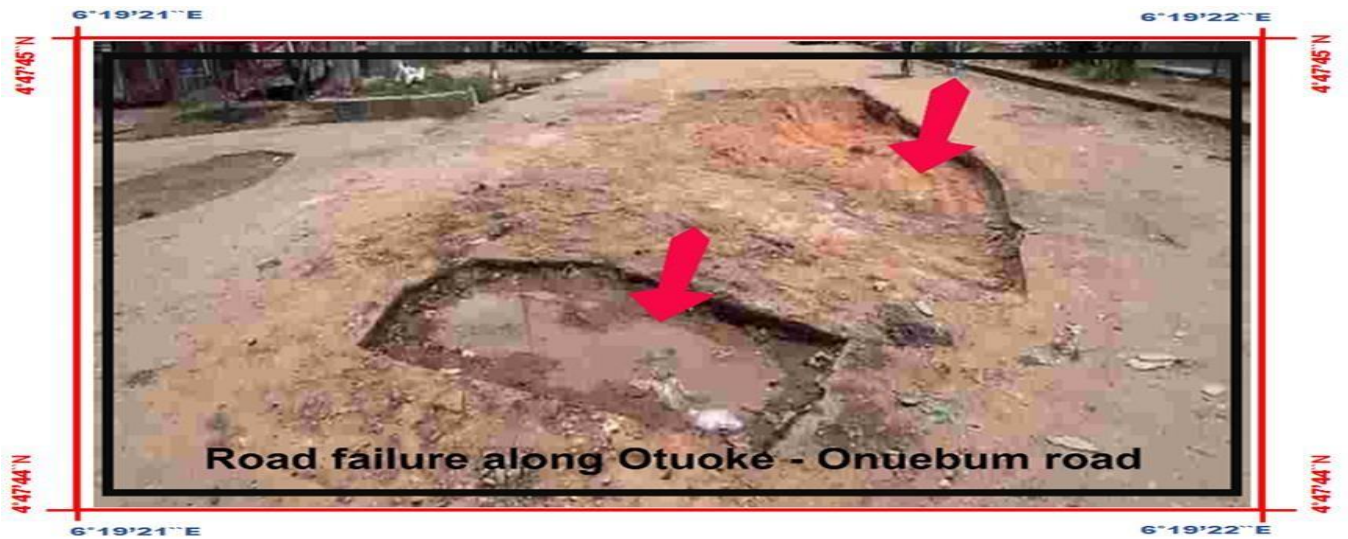
Figure 2: Image of failed portion of Otuoke – Onuebum road.

Road construction and rehabilitation work along Imiringi - Emeyal 2 and Otuoke-Onuebum Roads do not stand the test of time; it is therefore recommended that clay, peat, loam and mud deposits as well as highly weathered geologic materials existing beneath the roads should be excavated and replaced with more competent material like sand before laying the asphalt.

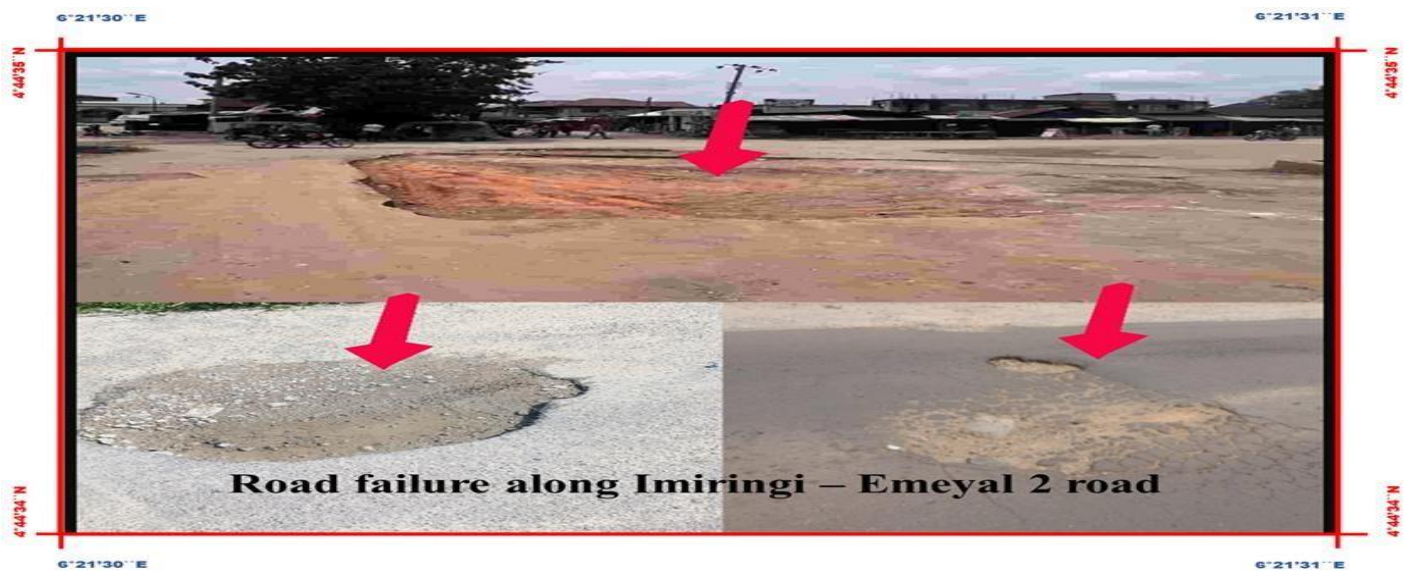
Figure 3: Image of failed portion of Imiringi – Emeyal 2 road

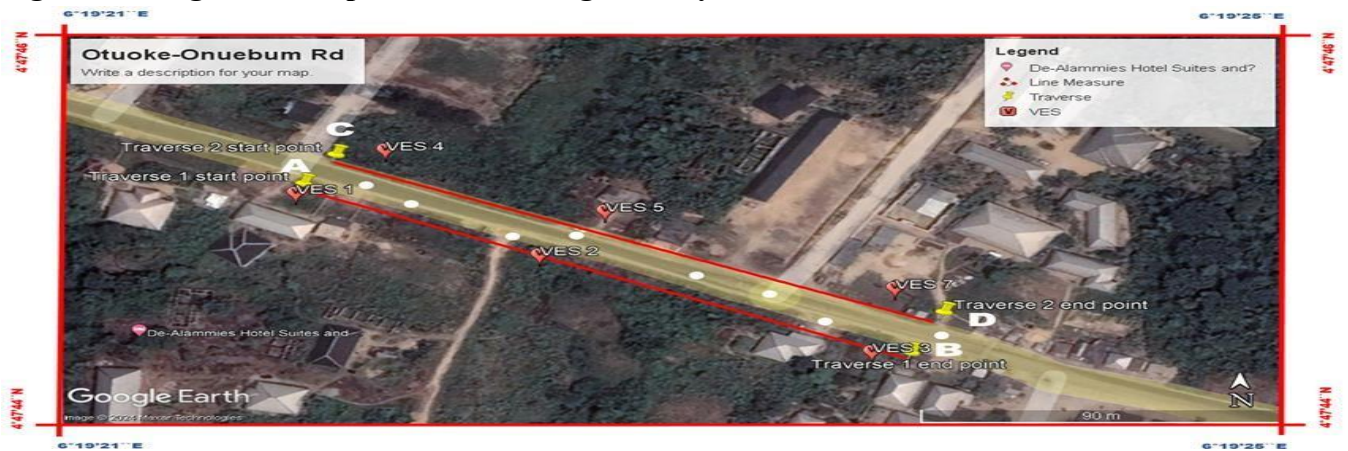
Figure 4: Google map of the study area showing Profiles where Data were collected along Otuoke - Onuebum Road.

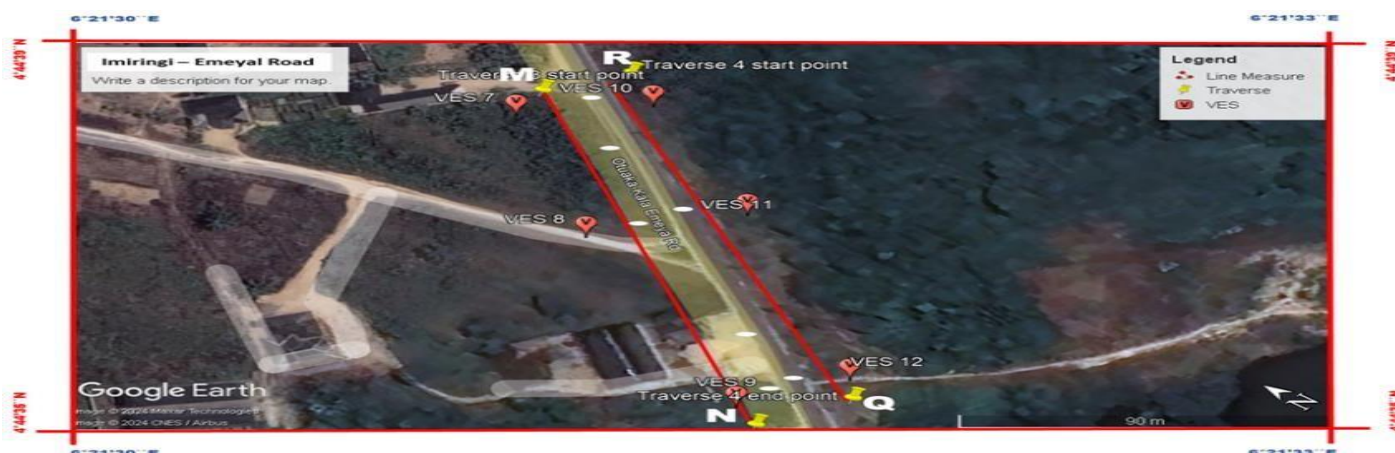
**Figure 5: Google map of the study area showing the Profiles where Data were collected along Imirigi - Emeyal Road.**
